NASA CR-54719

SNAP-8 MATERIALS REPORT FOR JANUARY-JUNE 1965

BY H. DEROW AND B. E. FARWELL

REPORT NO. 3038 (SEMIANNUAL) / JULY 1965 / COPY NO. **13**

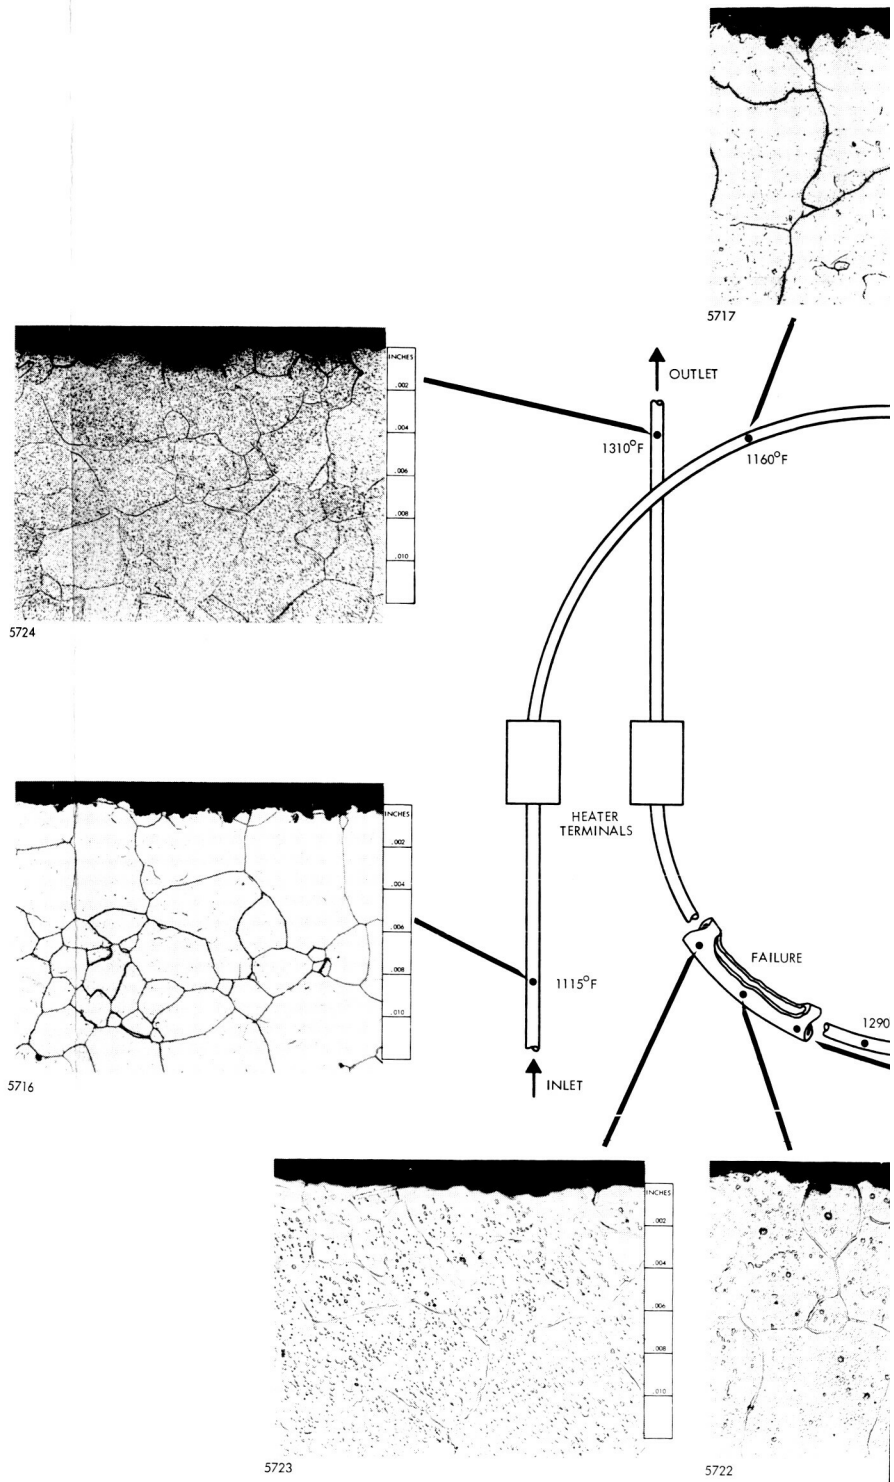
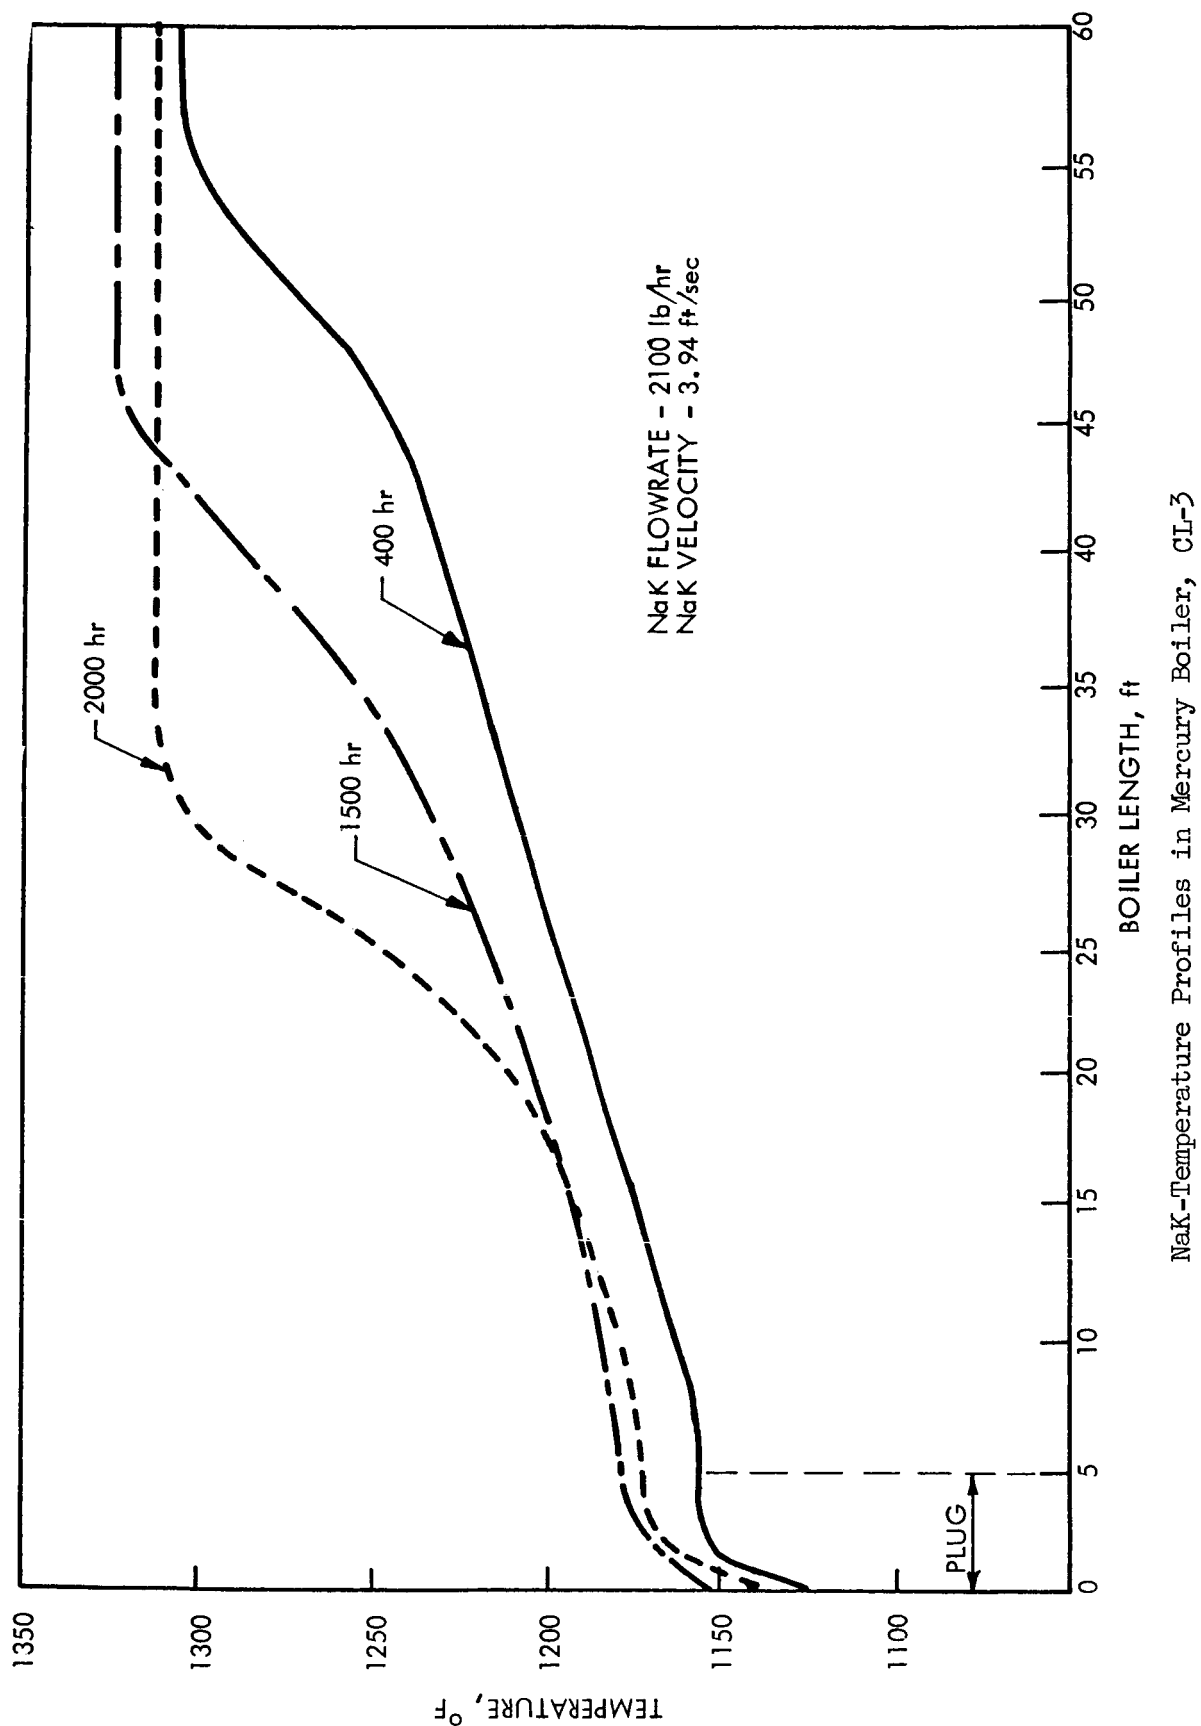
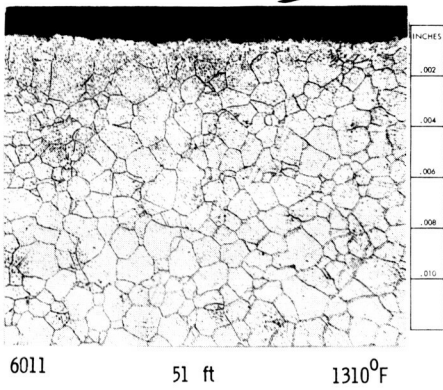
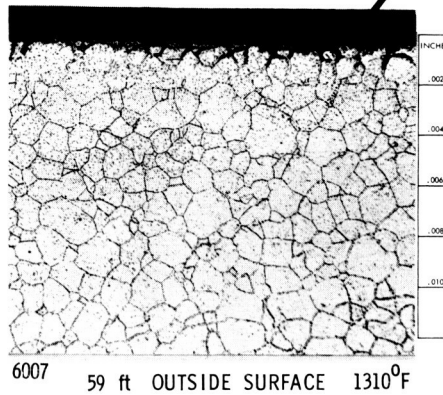
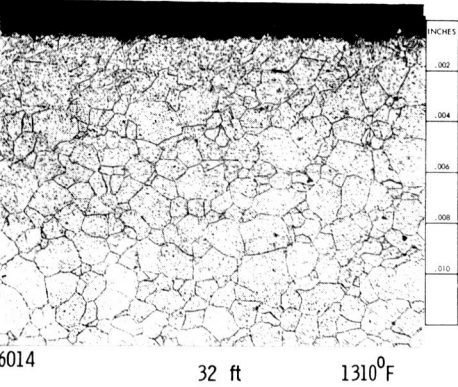
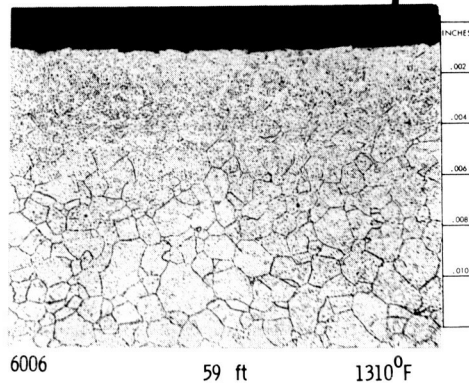
Figure 16

The 316 SS outer shell of the mercury boiler showed no evidence of corrosion. There was some carburization of the 316 SS in the hottest section (1310°F) of the boiler (Figure 16).

ell, CL-3 Boiler (Vilella's Etch)

Microstructure of 316 SS Outer Sh

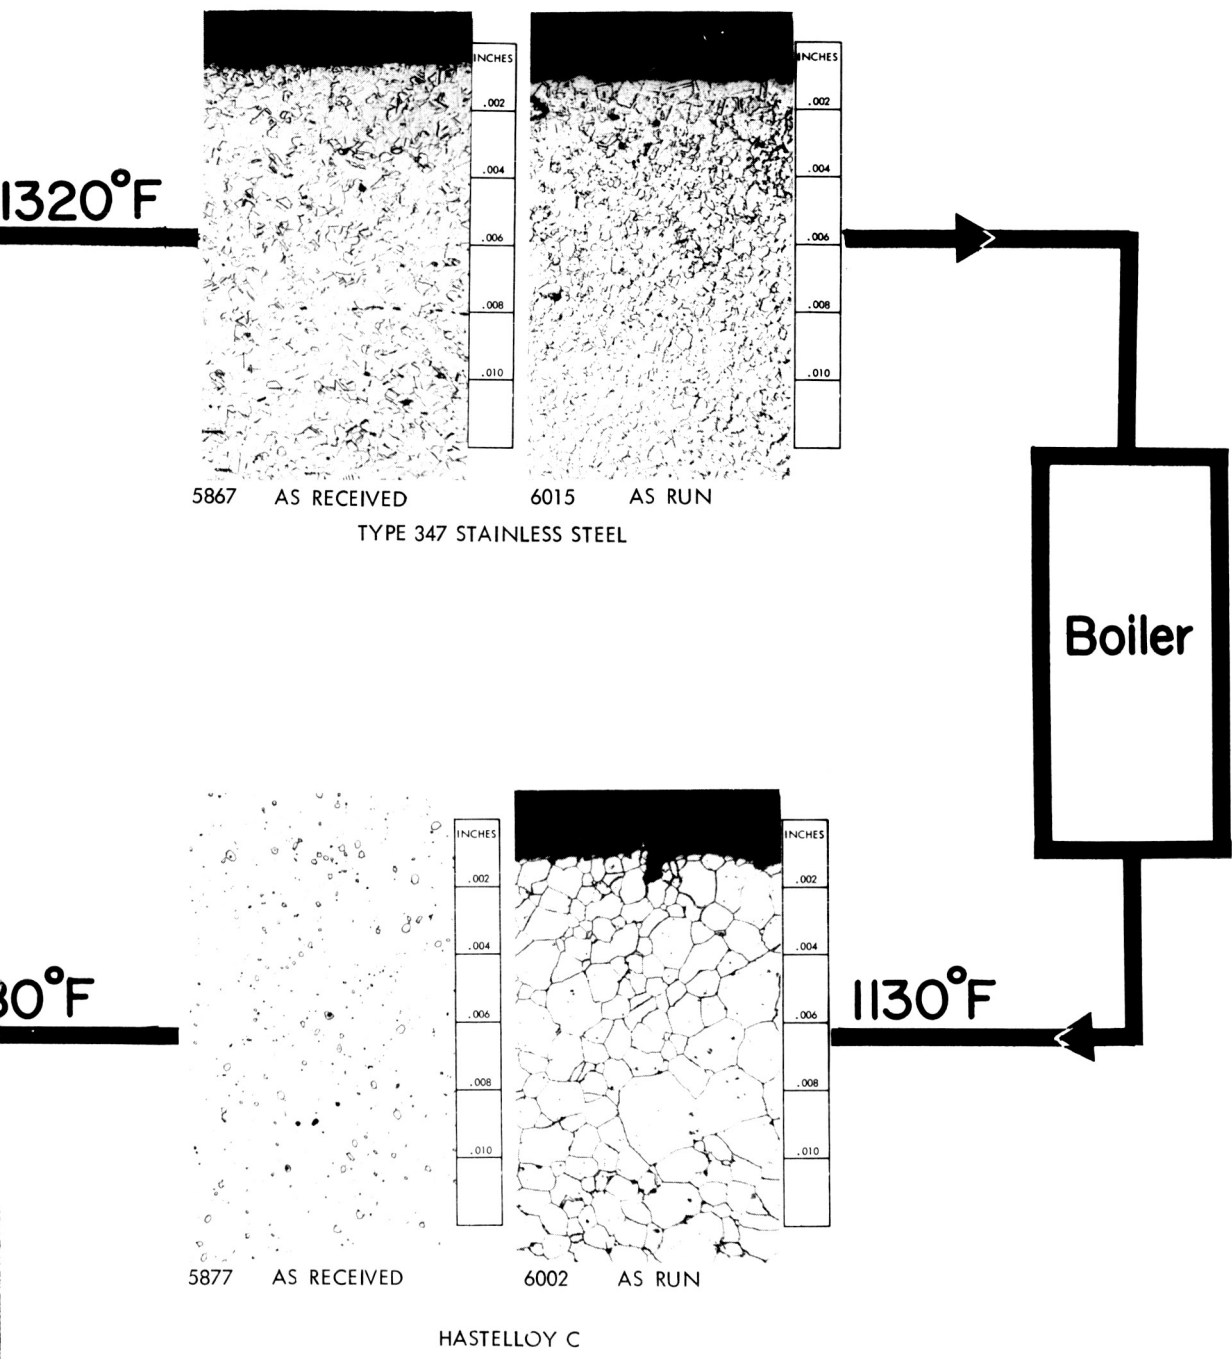
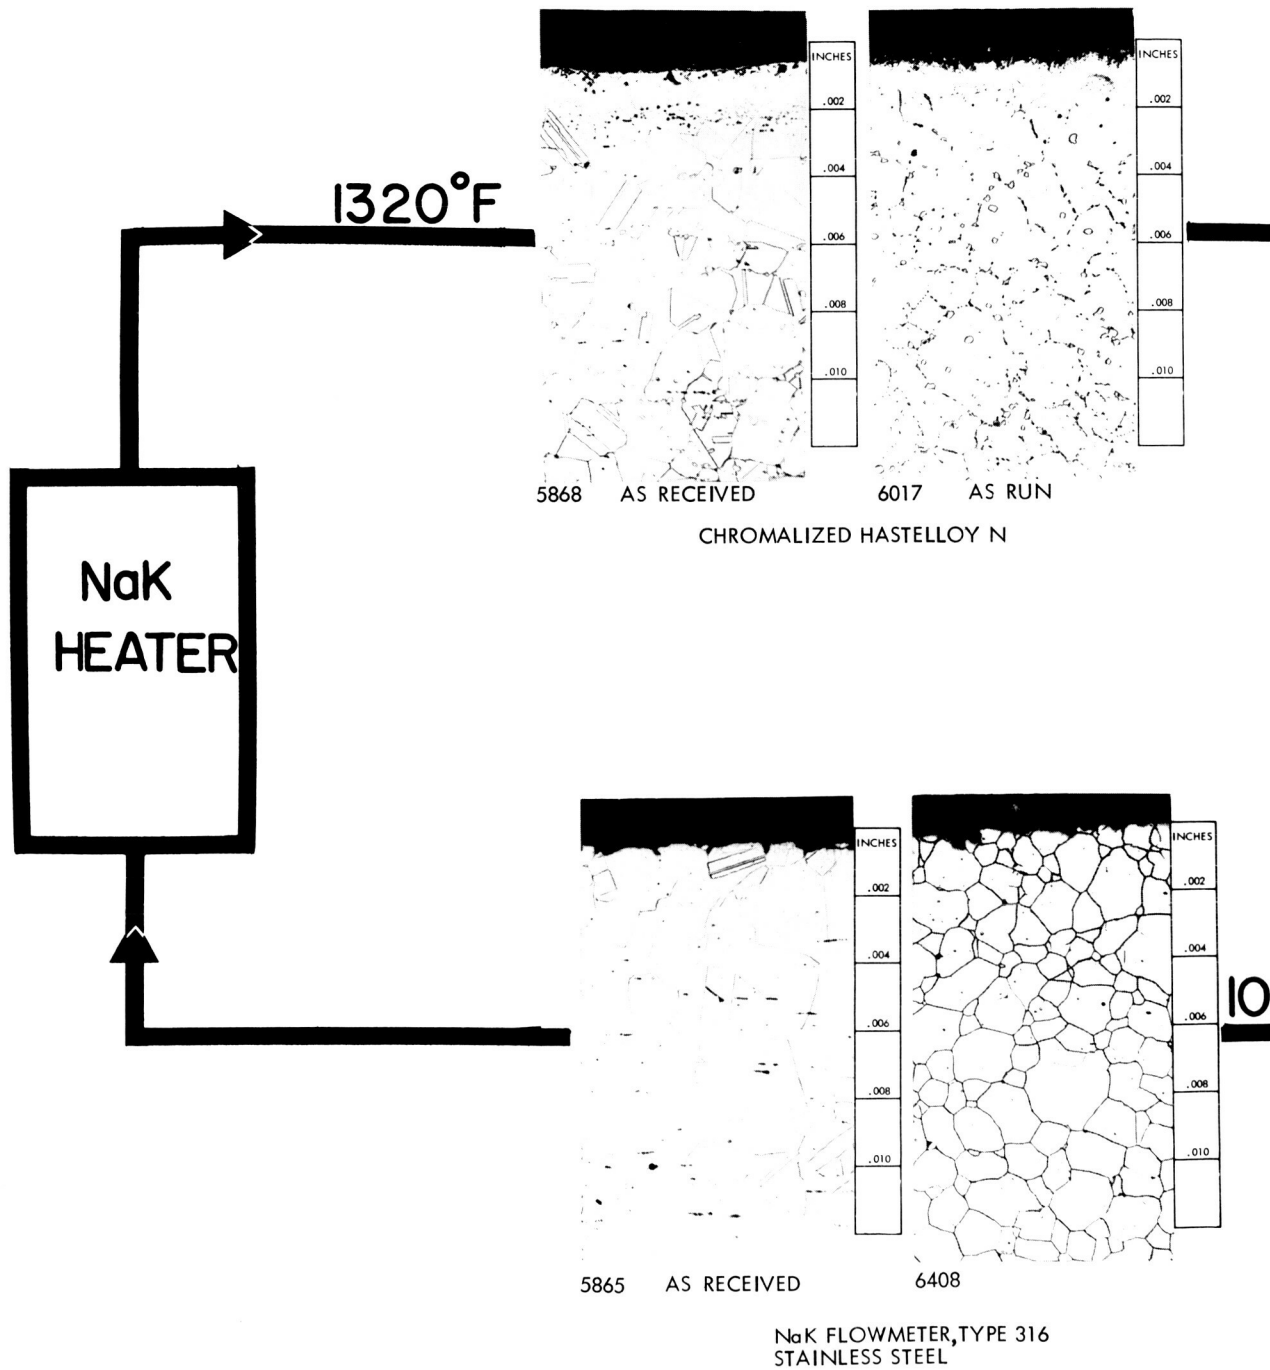
Figure 18

Other components in the NaK primary system (e.g., the EM pump, EM flowmeter, and 316 SS tubing) showed no indications of corrosion or mass transfer. The sections of Chromalized Hastelloy N, 347 SS, and Hastelloy C incorporated to simulate reactor materials showed no appreciable corrosion (Figure 18). The 347 SS in a high-temperature section of the NaK primary system (1320°F) showed less change in microstructure than the 316 SS.

Primary Loop, CL-3 (Vilella's Etch)

Microstructure of Materials in NaK

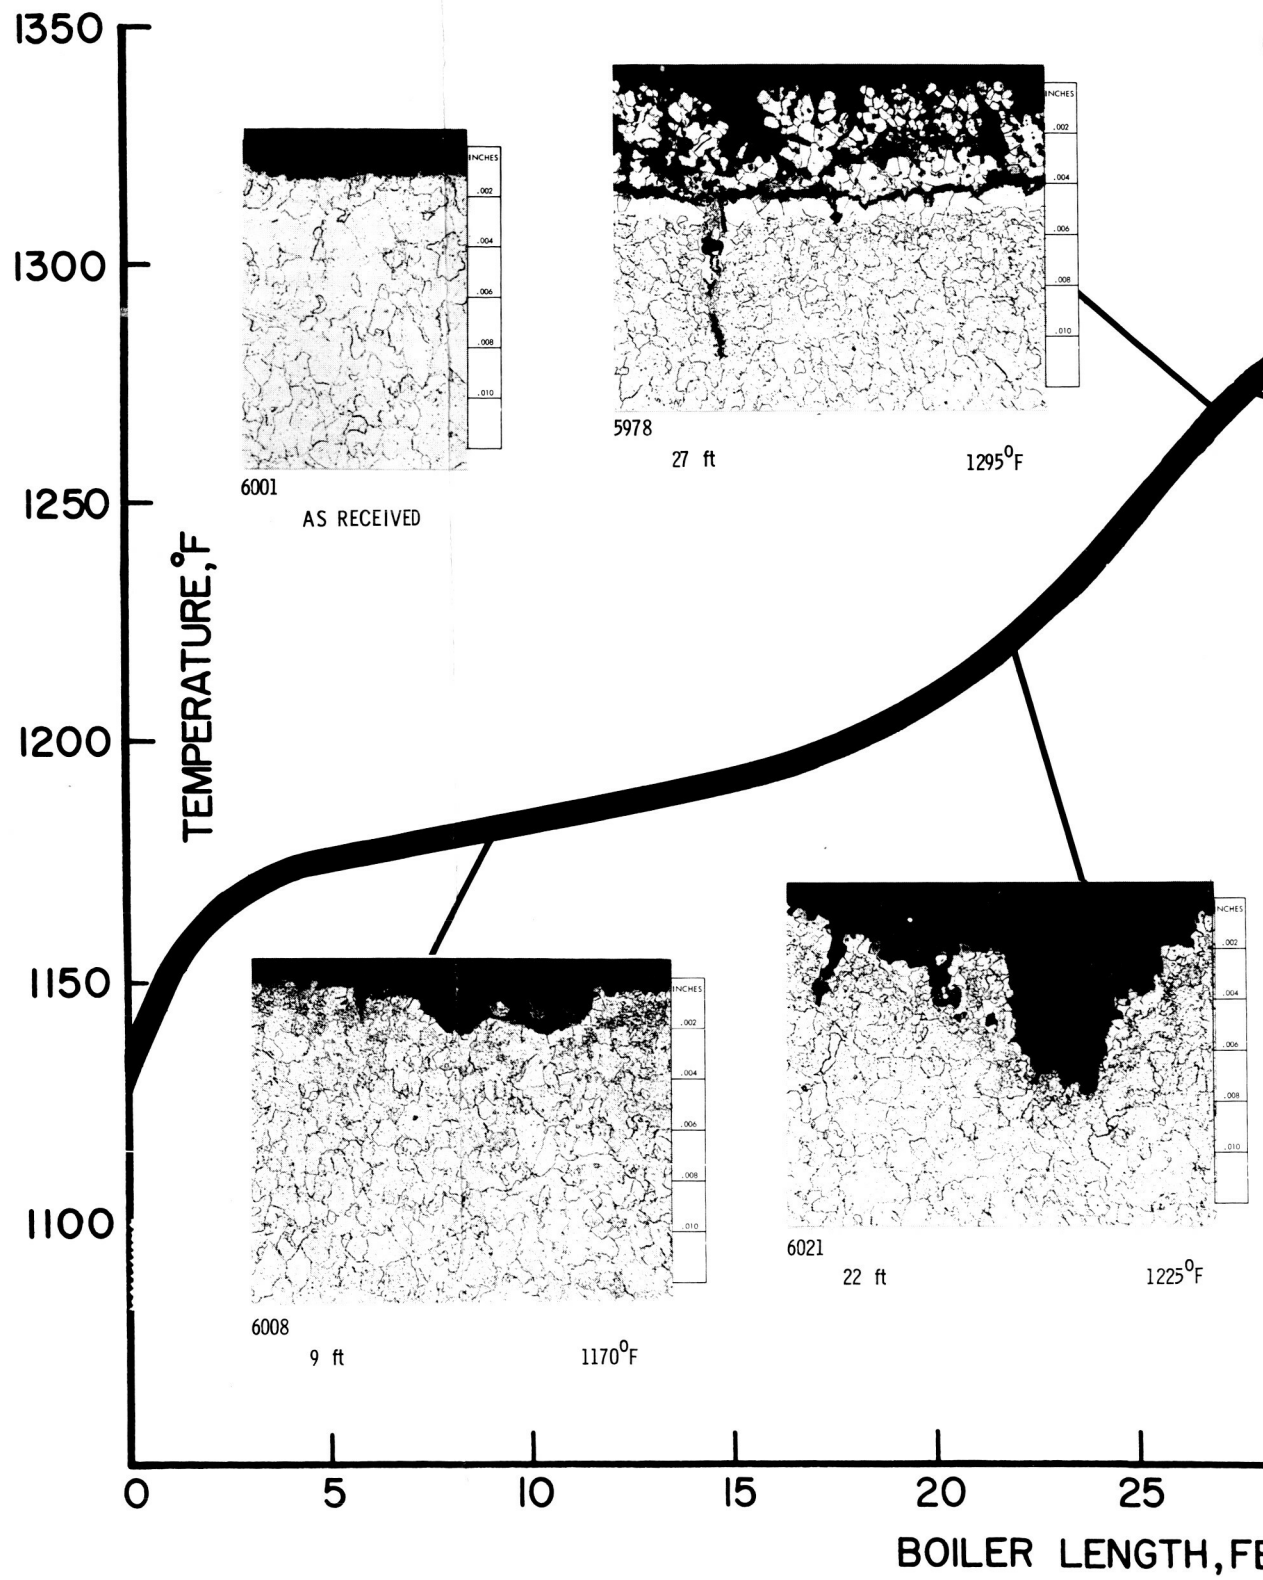
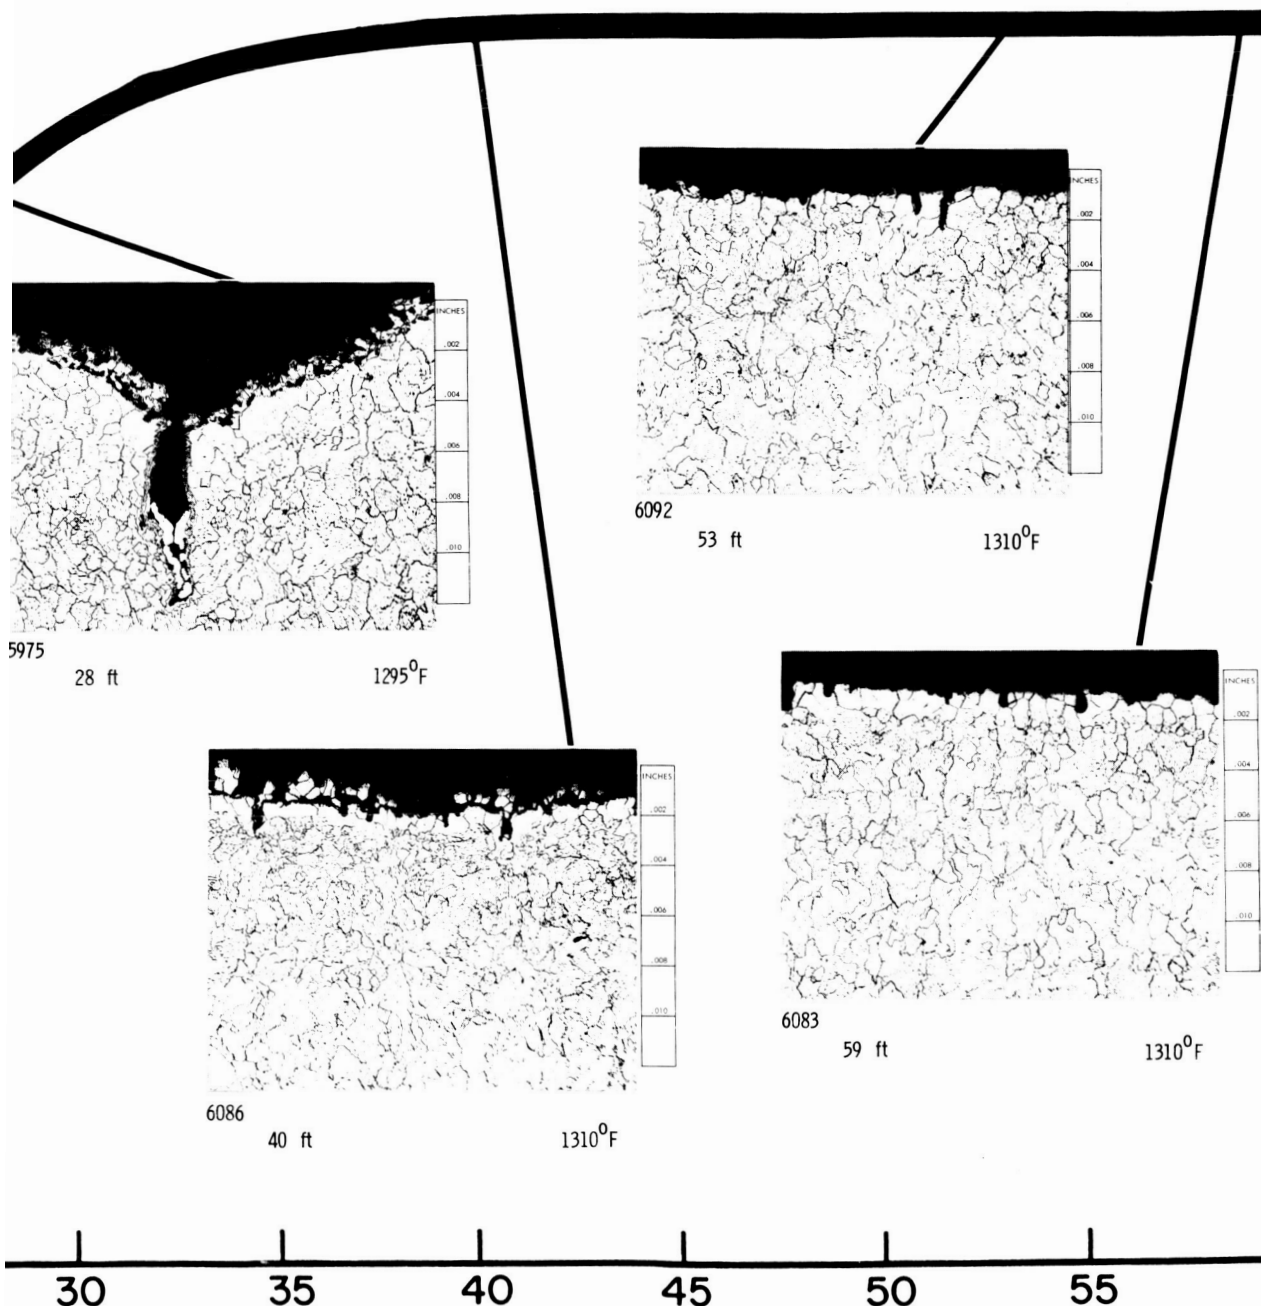
Figure 22

The microstructure of the interior of typical sections of the tubing is shown in Figure 22. Tube cracking can again be seen in the boiler area where the maximum heat transfer occurred. Corrosion-product deposition is also shown.

Microstructure at Interior of 9Cr-1Mo St

Steel Tubing, CL-3 Boiler (Vilella's Etch)

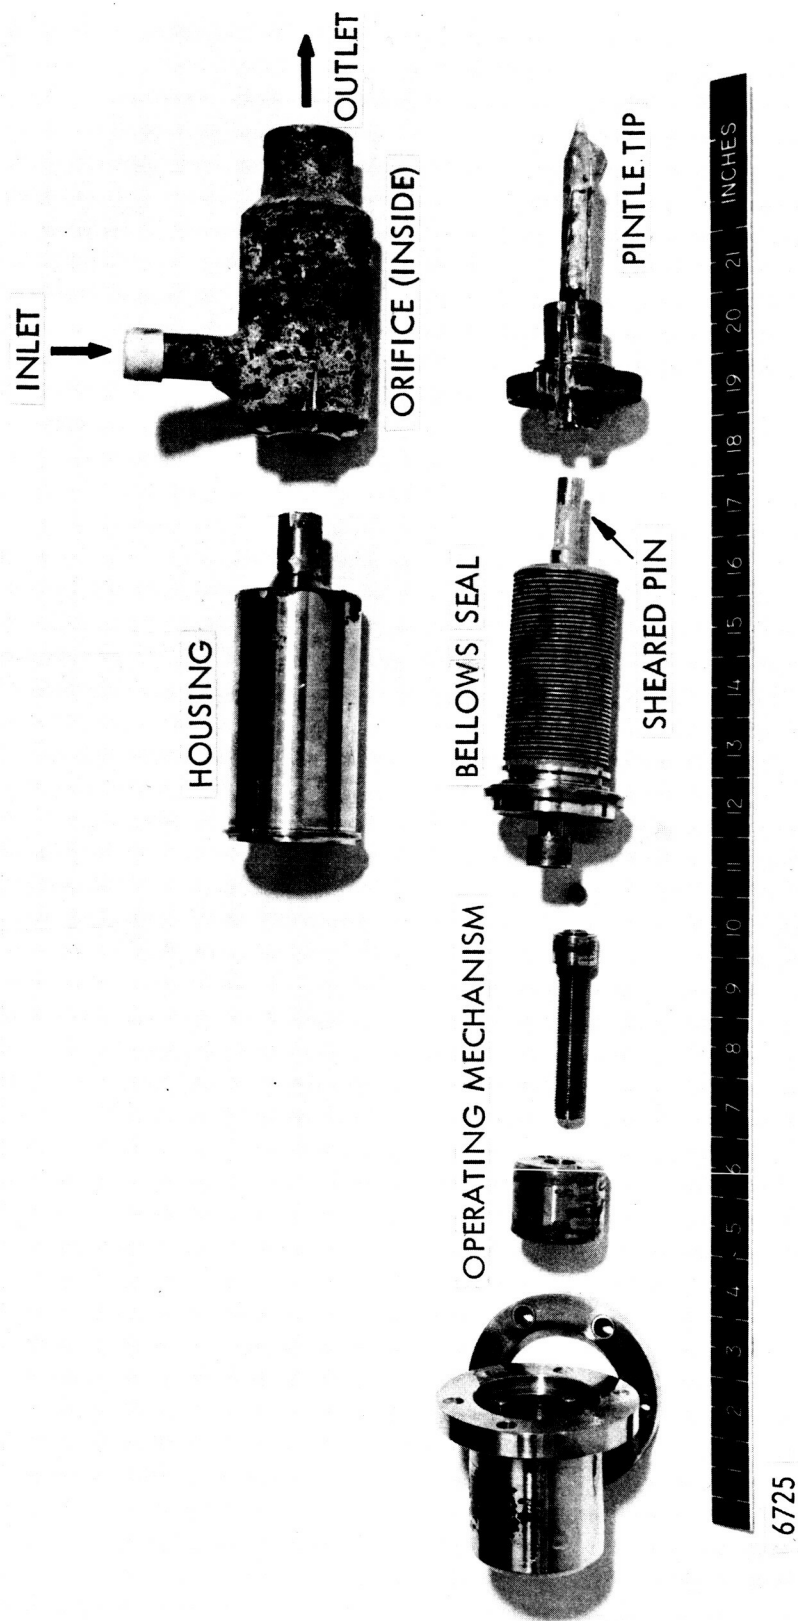
Figure 23

The adjustable choked nozzle, which could not be adjusted during the last portion of CL-3 operation, was disassembled (Figure 23) and examined visually. A sheared pin was found in its operating mechanism. The Stellite 6B nozzle and pintle tip were not eroded by the mercury vapor; there was a slight amount of corrosion-product buildup in the nozzle, and the pintle tip and nozzle were wetted by the mercury.

Adjustable Choked Nozzle, CL-3

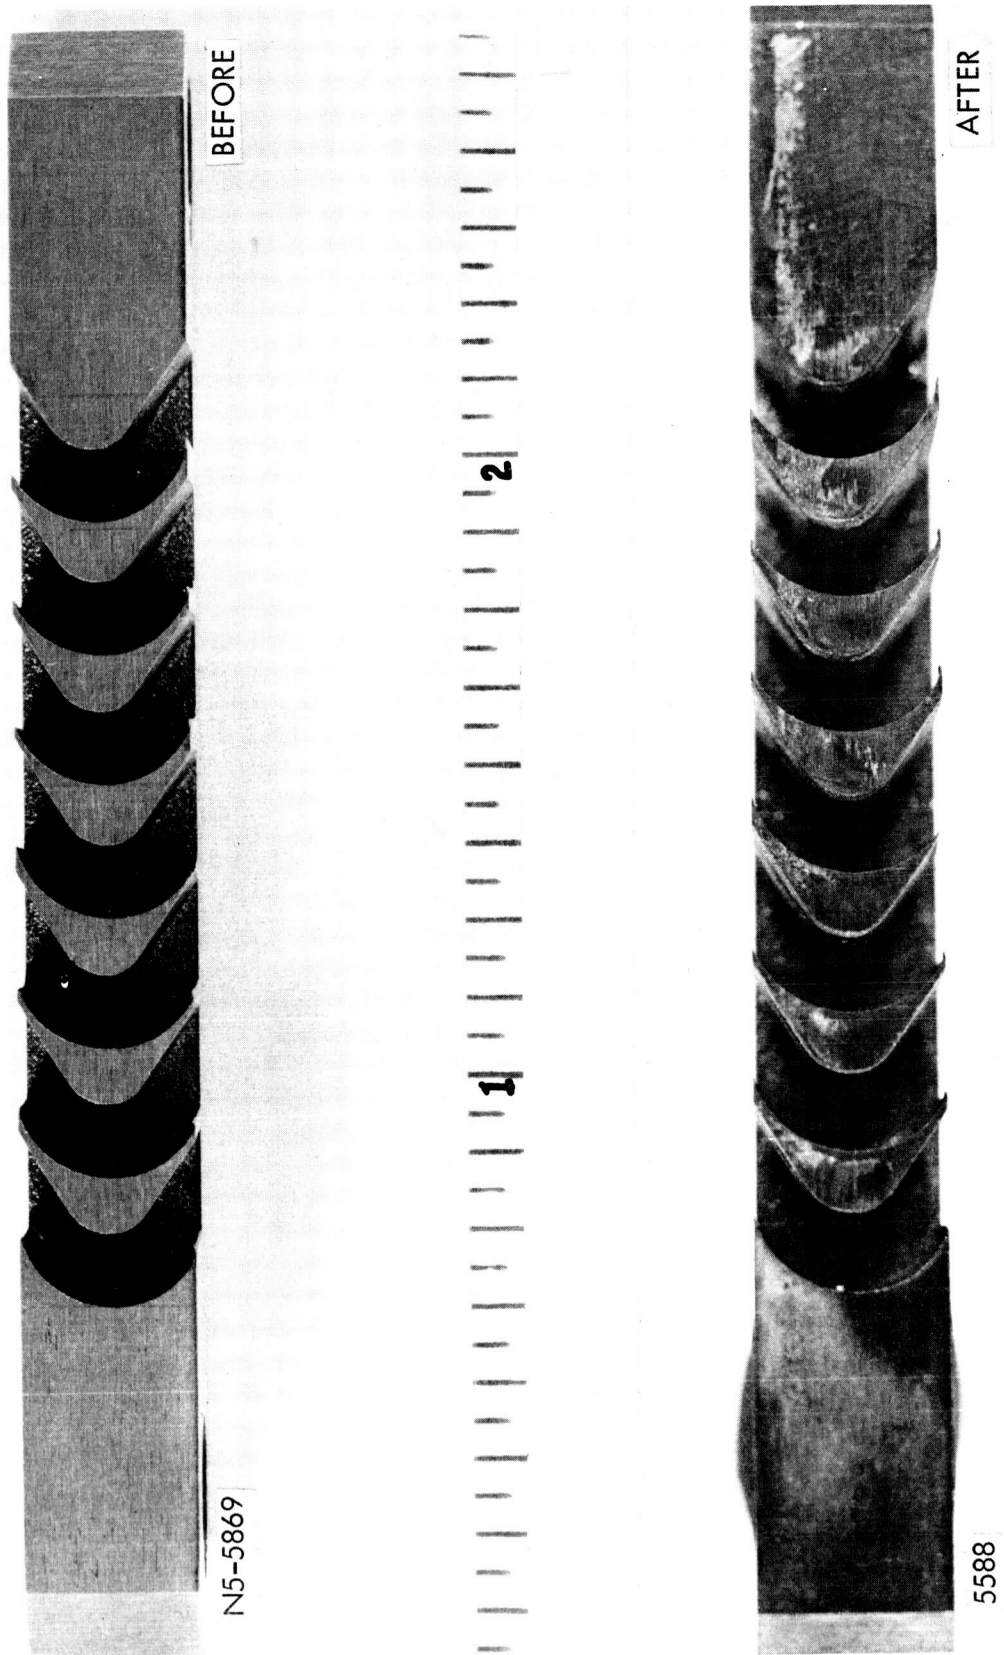
The blade-mockup assembly was disassembled, and the blade section was removed for inspection. Figure 24 compares the blade section before and after exposure. The vapor velocity through the blade section was estimated at 206 fps, and the vapor quality was 75% at 715°F. Exposure to these conditions produced no corrosion, mass transfer, or erosion in the blade section.

Blade Section Before and After Exposure, CL-3

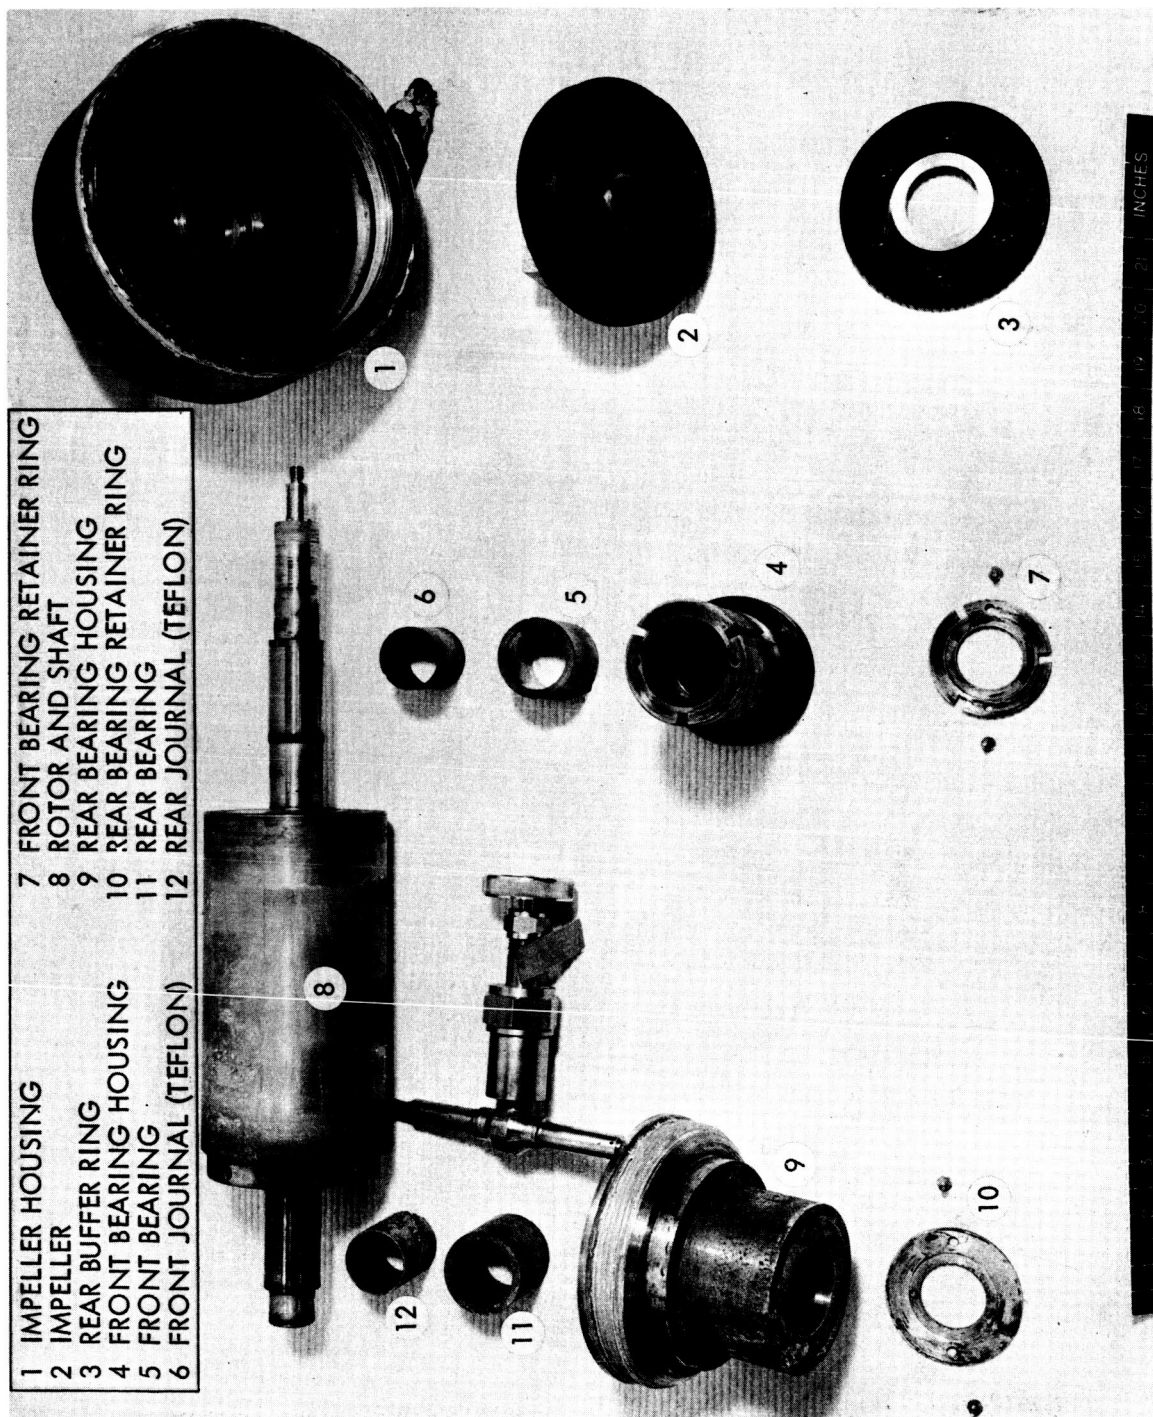
Figure 25

This pump was operated for a total of 3971 hours in CL-3. It was then disassembled and inspected for wear, mass-transfer deposits, and erosion. The inspection indicated some Teflon-journal wear (Figure 25, Parts 6 and 12), a crack in the flange area of the front bearing housing (Figure 25, Part 4), and wear marks on the lower side of the hydraulic equalizing grooves. The journal wear amounted to approximately 0.025 in. The crack in the front bearing housing appears to have resulted from thermal stress in a weld area. Considerable weld metal was machined off during the finishing operation, and the indications are that the heat buildup in this area was caused by rubbing of the impeller's hydraulic balancing vanes against the housing.

There were also indications that the shaft was rubbing on the bottom of the shaft hole. The rub marks were all on the lower side of the case, indicating that the Teflon-journal wear was excessive and allowed the impeller shaft to drop and rub, thereby causing abnormal heat buildup. No mass-transfer deposits or erosion were found inside the impeller case or on the impeller (Figure 25, Parts 1 and 2).

Internal Parts of Mercury Pump (9Cr-1Mo Steel), CL-3

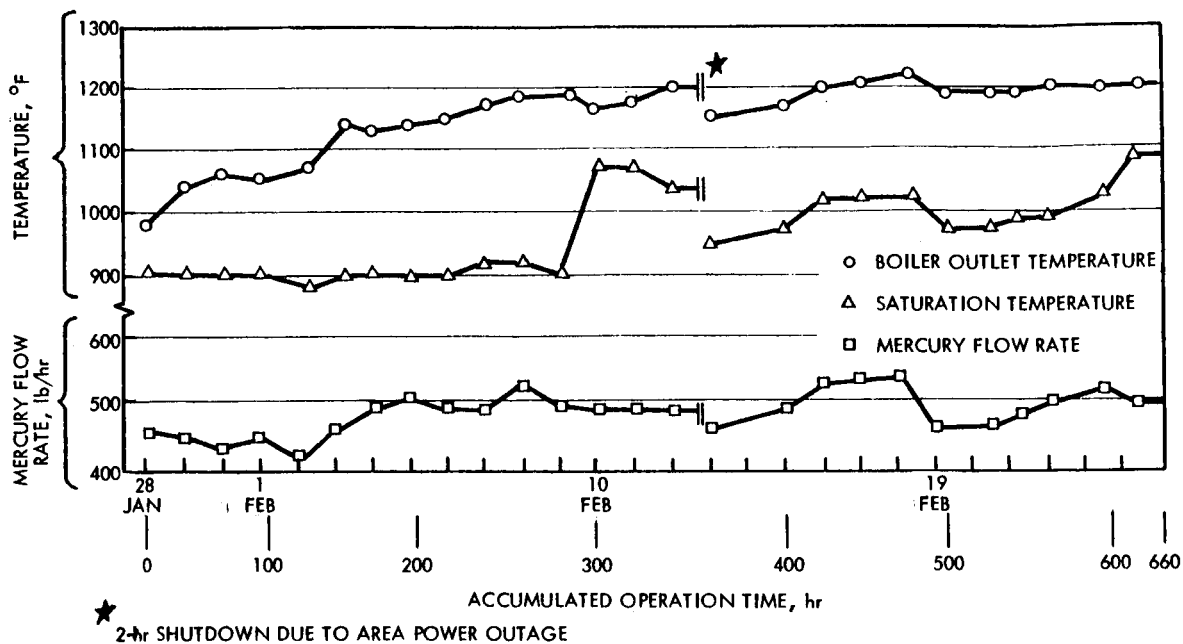
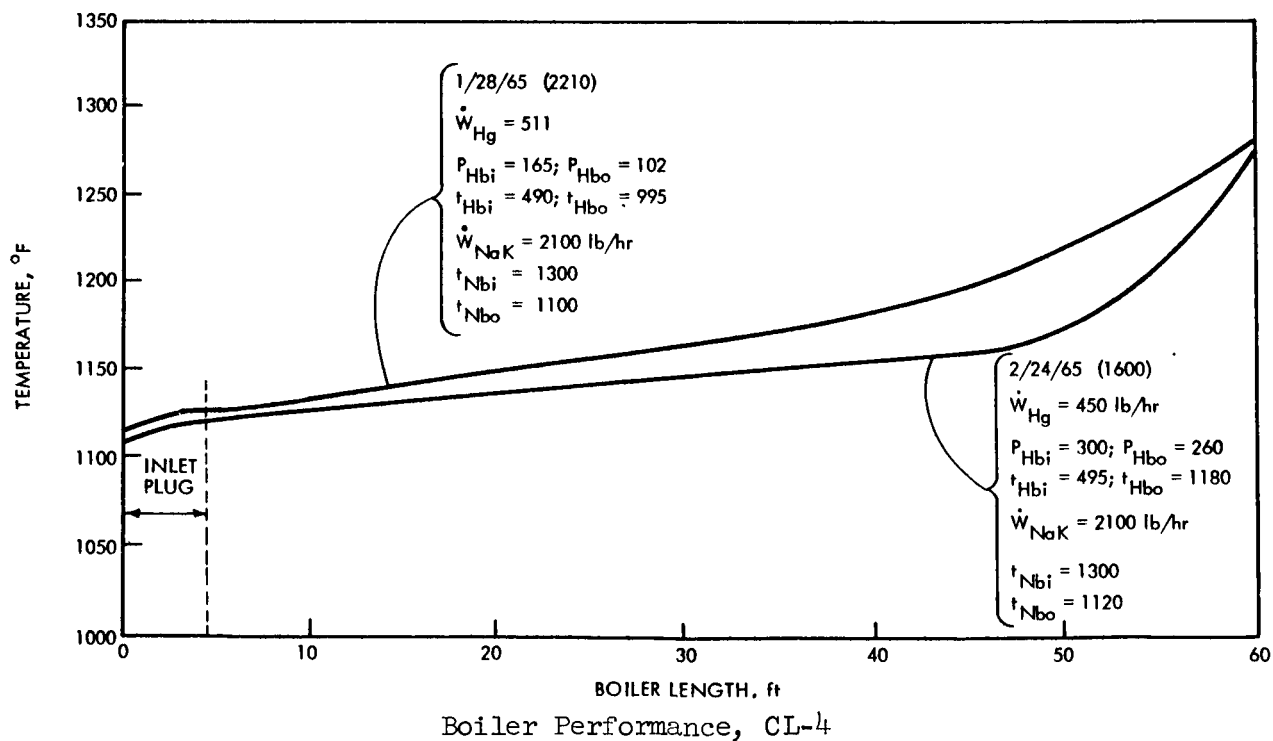
Figure 26

A slight improvement in boiler performance was noted, on the basis of NaK-shell-temperature profiles taken at the beginning and end of the run (Figure 26). These profiles showed that some conditioning had occurred in the last 15 ft of the boiler; they also indicated that an extended run-in period is required to condition the boiler.
